# Eskal

## BULLETIN

BULLETIN 16

SUBJECT: Scrapper Fingers, Guard Spring and Wire on Casting Chute.

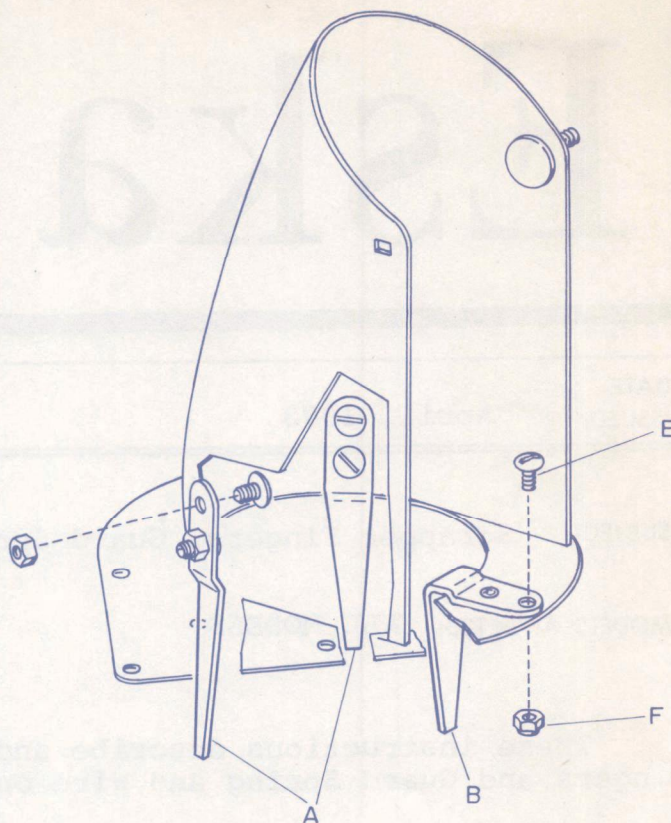
Figure 1

Step 5. Install two (2) back (Key A) and one (1) front scrapper fingers (Keys B) using five (5) screws (Key E) and nuts (Key F) as shown in Figure #1.

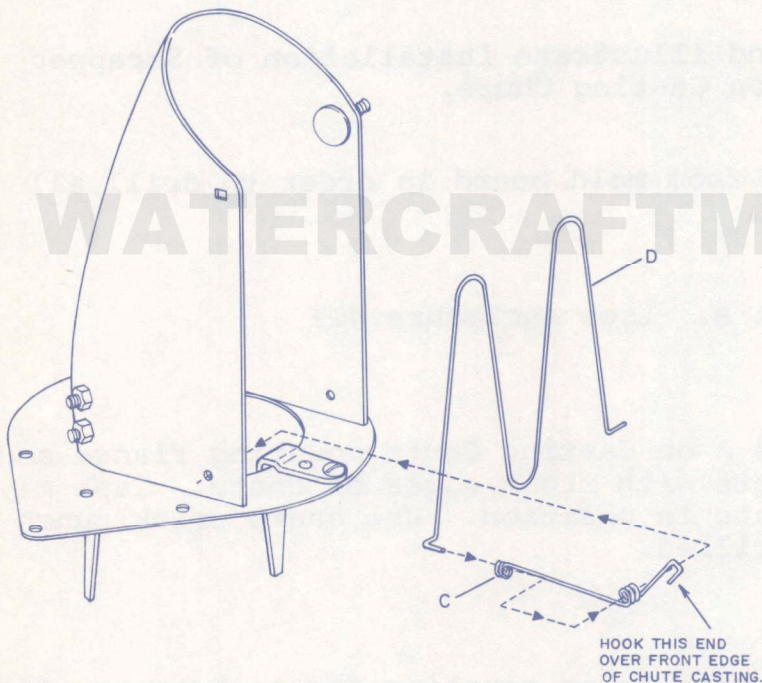
Figure 2

Step 6. Install Guard Spring (Key C) on guard wire (Key D) as shown in Figure #2.

Step 7. Hook square end of Guard Spring on front edge of casting chute flange and then insert end of Guard Wire into spring hole on right side of Chute. Install other end in opposite spring hole.

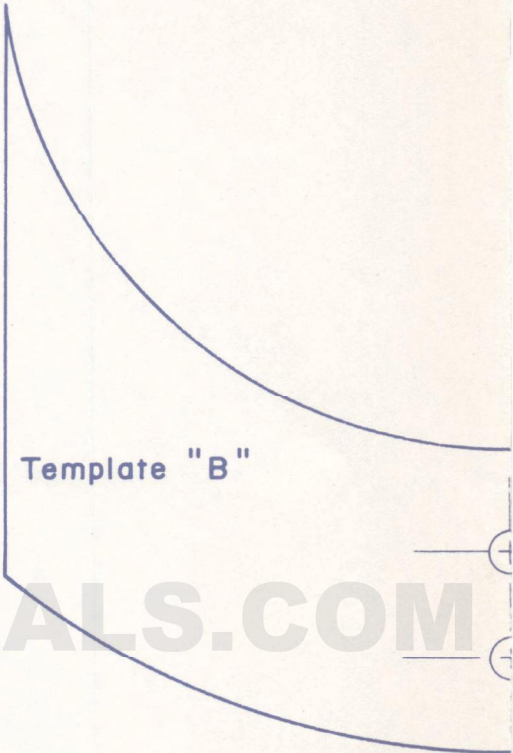
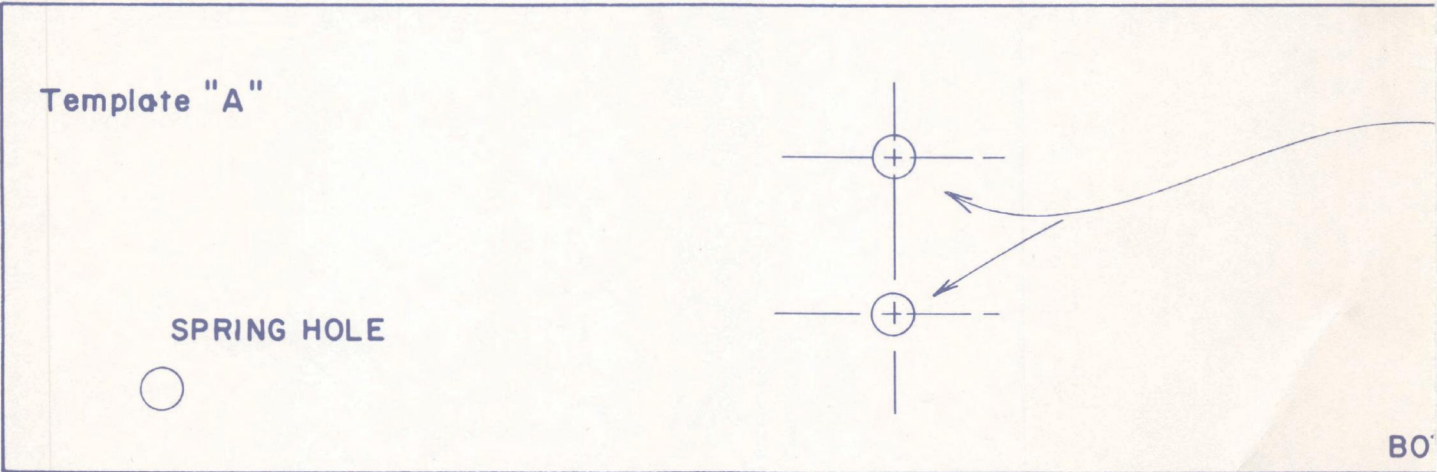
Enclosure #1

To install fingers use 3/16 drill and drill holes as indicated on templates.  
Place fingers in position and tighten screws with locknut.

3/16 DIA  
FINGER HOLES

SPRING HOLE

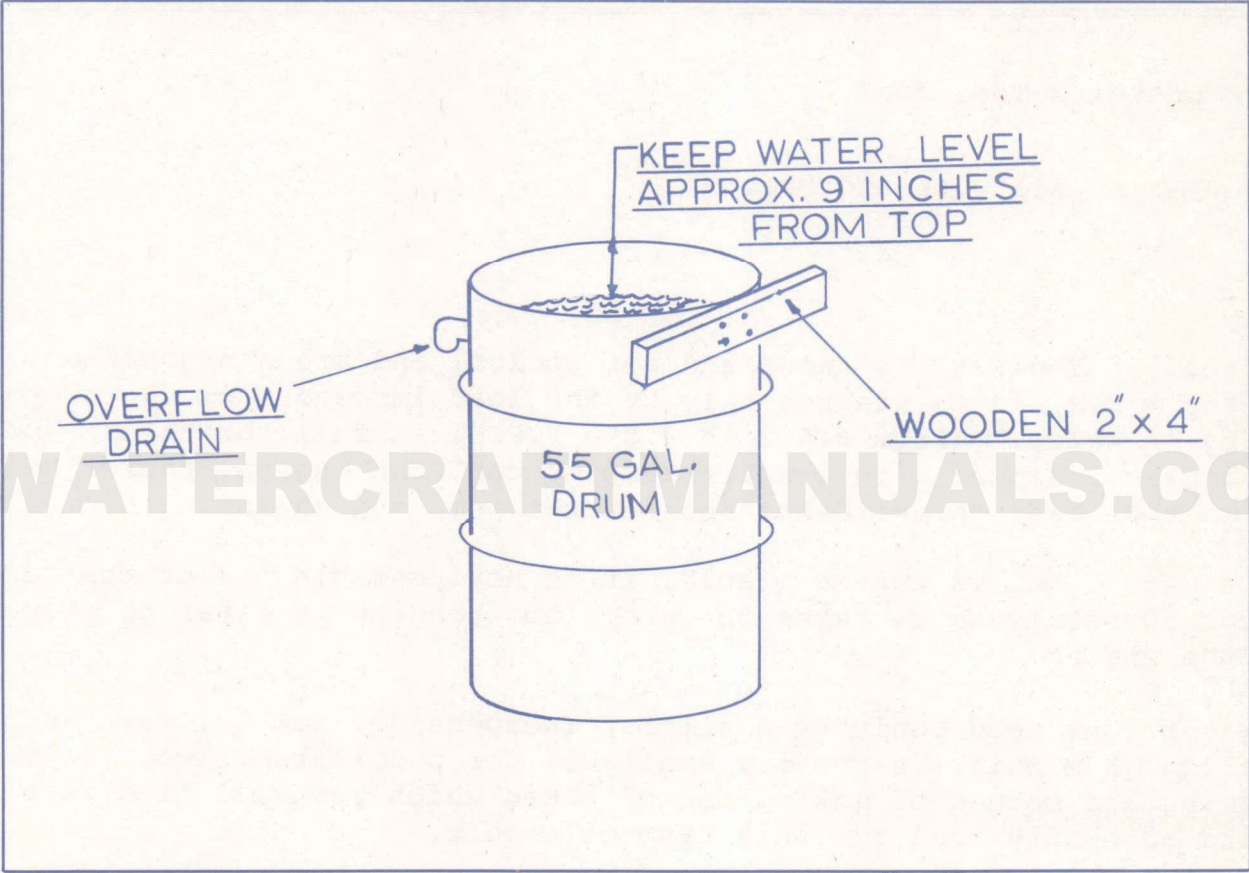
### O U T B O A R D T E S T T A N K

Cut drum top and install overflow tube, as shown on these drawings. When mounting the outboard, place a 2 x 4 on the side of the drum, at the top, and pull it up tight using the outboard's own mounting system. When using your test tank do not allow outboard to operate above idle speed for more than a few minutes.

OVERFLOW  
DRAIN

KEEP WATER LEVEL  
APPROX. 9 INCHES  
FROM TOP

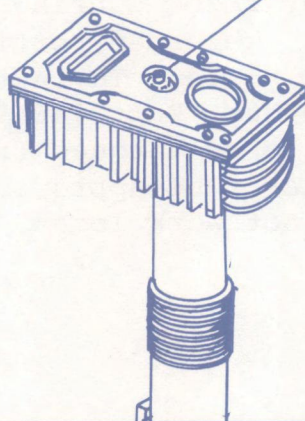
When removing water tube, Part #96549, from mounting plate, a new water tube, Part #96549, must be installed. Threaded portion of the water tube has been flared to secure to mounting plate. To install new water tube, secure mounting plate with Part #2835 Nut, Part #4849 Flat Washer, and Part #96168, Viton Seal Washer. Nut to be torqued from 23 to 25 inch pounds. Use taper punch to flare water tube approximately 3 degrees to insure proper fit so that it will not work loose.

FLARED END OF WATER TUBE  
PT. NO. 96549

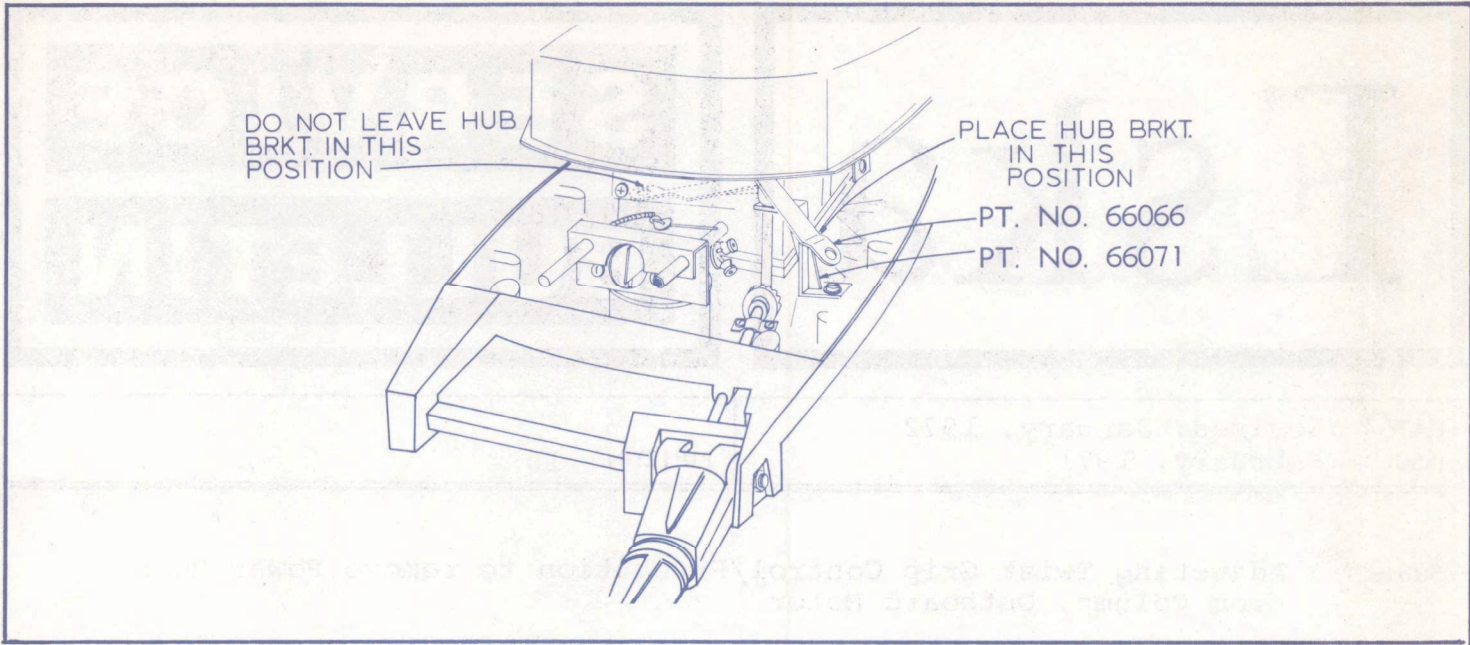
Figure 1

- A. Twist Grip Control must move with ease, but a drag should be noticeable to hold desirable speed without holding on to Twist Grip.
- B. When removing power head from column assembly, caution must be used to avoid unnecessary breakage of Twist Grip Control parts. Recommend throttle be in full-throttle position. This allows throttle hub bracket, Part #66066, and support bracket, Part #66071, to give clearance when removing power head. Always remove retaining ring, Part #7427, and rivet, Part #7607, to disengage the power head throttle control lever from the Twist Grip Control. (See Fig. 1)

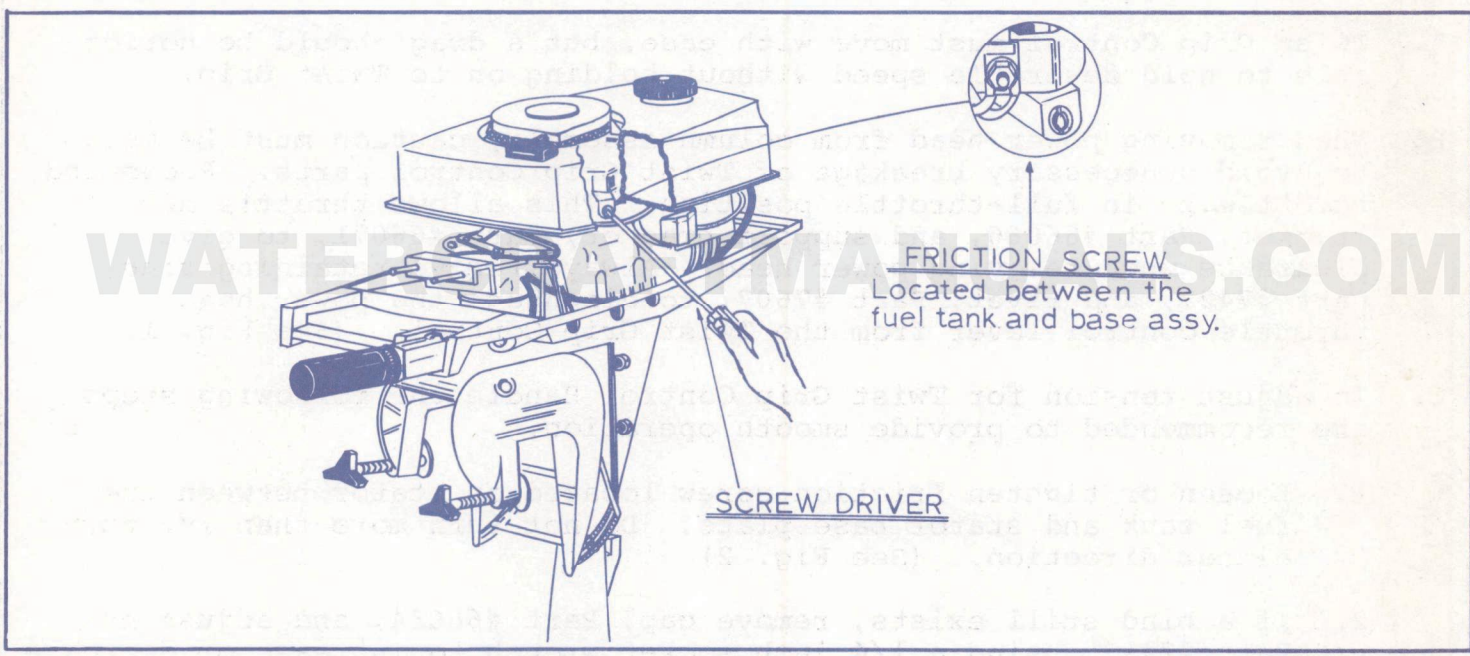
Figure 2

- C. To adjust tension for Twist Grip Control Handle the following steps are recommended to provide smooth operation.
1. Loosen or tighten friction screw located on stator between the fuel tank and stator base plate. Do not turn more than 1/2 turn either direction. (See Fig. 2)

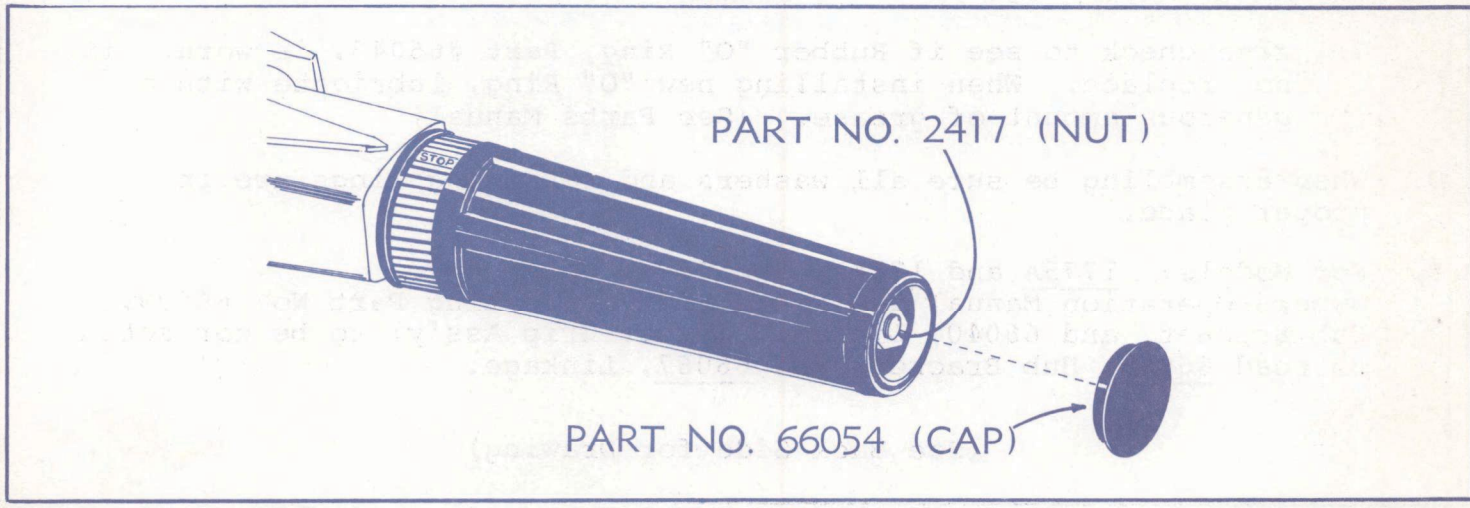
Figure 3

2. If a bind still exists, remove cap, Part #66054, and adjust nut, Part #2417, using a 1/4 inch socket wrench to increase or decrease drag. (See Fig. 3)

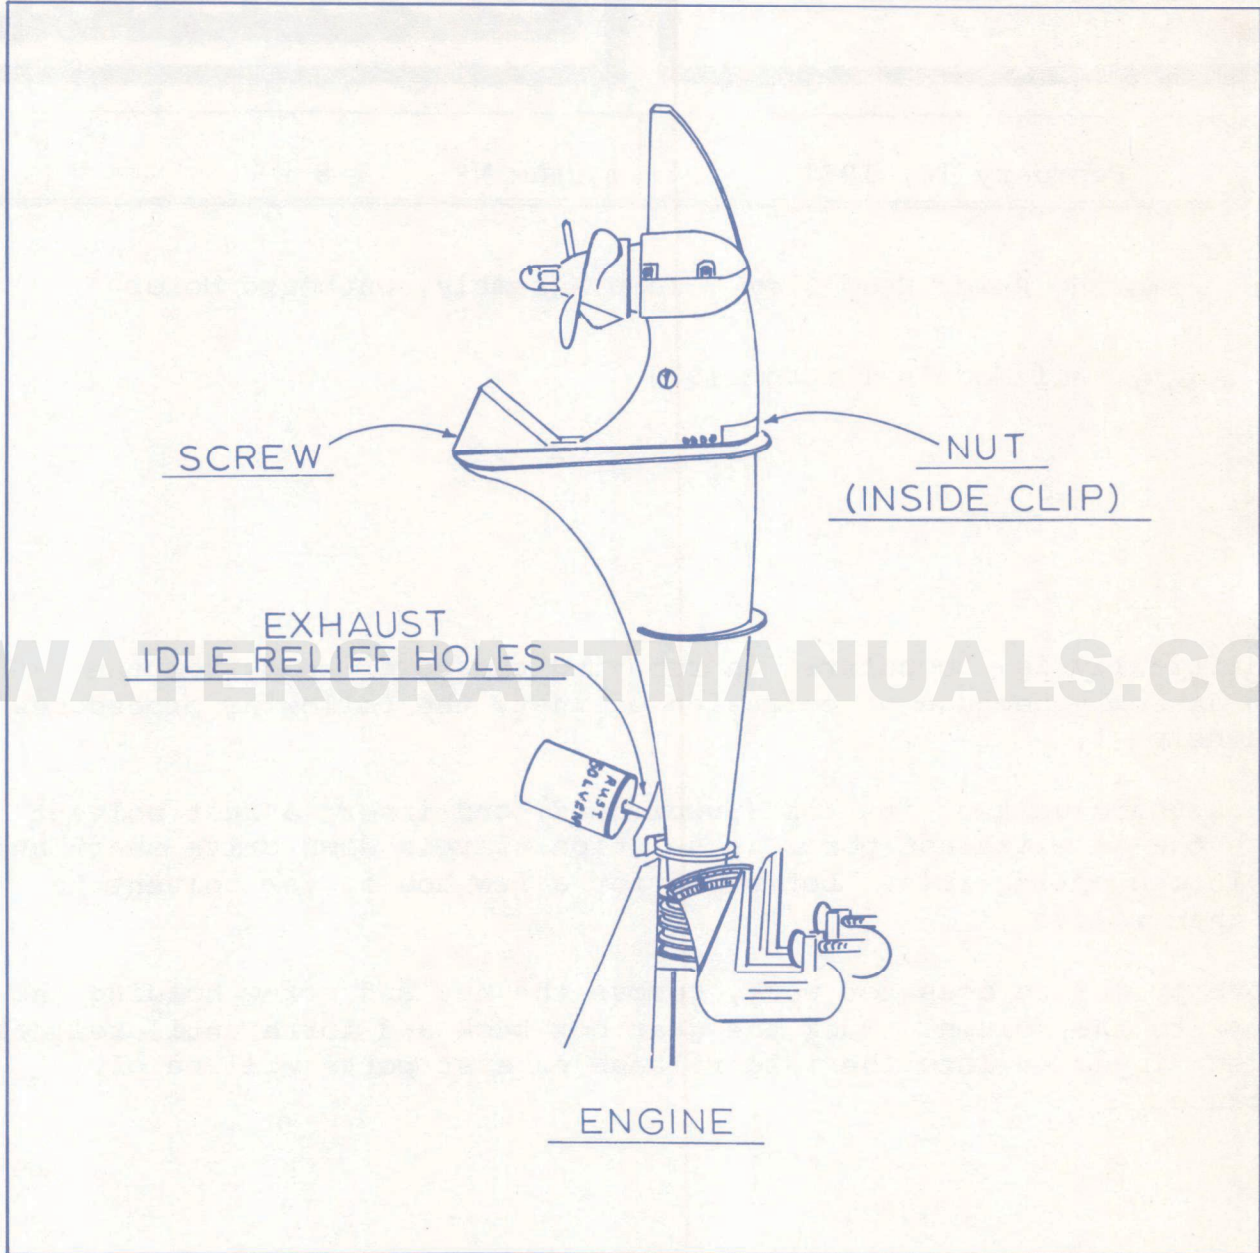
When difficulty is encountered in removing the power head from the column assembly because of corrosion or rust, the following procedures may be helpful.

Stand outboard unit on its top (power head) and insert a rust solvent through the idle exhaust ports so solution travels down drive shaft and works into coupling area. Let stand for a few hours, for solvent to work, then remove.

If above procedure does not work, remove the nut and screw holding the gear box to the column. Rock the gear box back and forth until released. A solvent injected into the idle release exhaust ports will be of assistance.

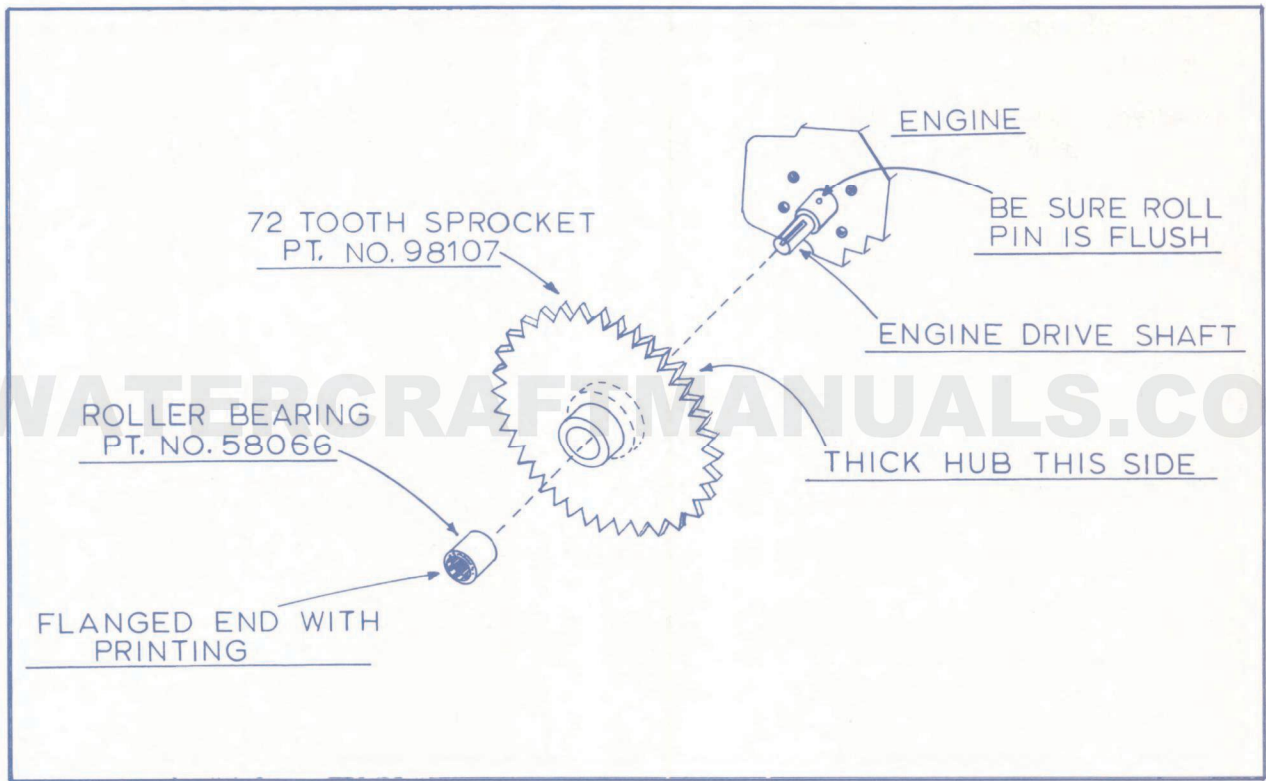
To install clutch roller bearing, Part #58066, make sure the flange side indicating printing is pointed toward end of crankshaft and not toward engine block.

Be sure roll pin is counter sunk below the surface on both sides of shaft.

Seventy-two (72) teeth sprocket, Part #98107, thick hub side to face toward Engine Block.

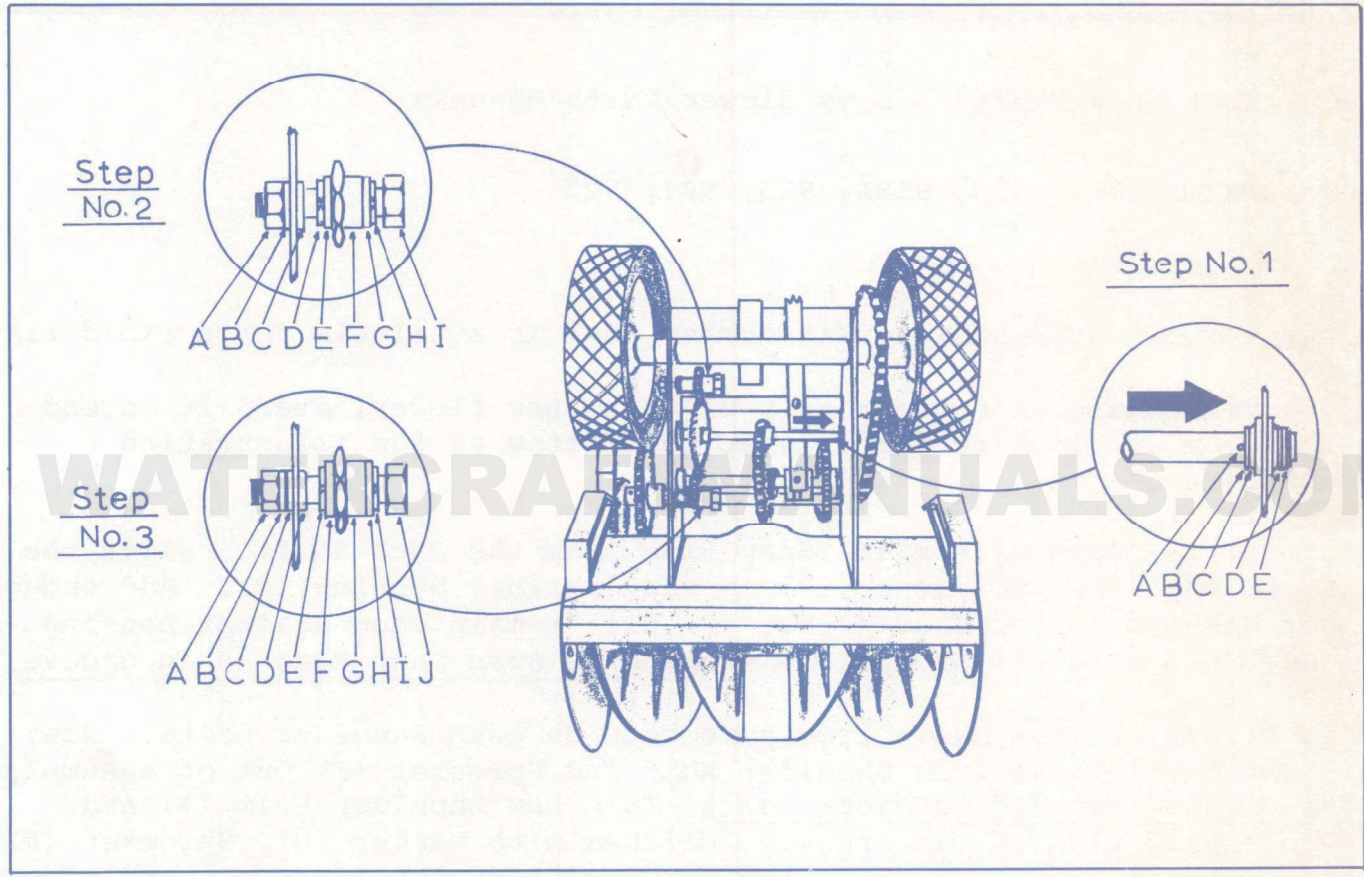
To repair bent jack shafts, Kit Number SB-1 is available for a field fix.

(Step No. 1) Remove Item (E) Snap Ring from the Jack Shaft. Slide the shaft to the right so Washer (B) is snug against Bearing (C). Add enough Spacer Washers (D) so that Washer (B) will remain snug against Bearing (C). Replace Snap Ring (E) on Shaft. (Note-Make sure Snap Ring is in groove.)

(Step No. 2) Remove chain from sprockets on both Shoulder Bolts. Now, take off Nut (A) and pull Shoulder Bolt and Sprocket (F) out of assembly. (Note-Discard removed Shoulder Bolt) Take new Shoulder Bolt (I) and assemble Snap Ring (H) in groove, followed with Washer (G), Sprocket (F), Washer (E) and Snap Ring (D). Add Washer (C) on Shoulder Bolt and place entire assembly back in Snow Blower. Assemble new Washer (B) and Nut (A) and tighten securely.

(Step No. 3) Step No. 3 is performed the same as Step No. 2, except for the adding of one Serrated Washer (C) under Washer (B).
